EVALUATION OF PHYSICAL SOIL AND WATER CONSERVATION STRUCTURES WITH RESPECT TO STANDARD PACKAGE IN ENEBSIE SARMIDIR DISTRICT: THE CASE OF GUANSA AND SHOLA WATERSHEDS, ETHIOPIA.

Abrham Mulu^{1*}, Enyew Adgo² and Zerihun Nigussie²

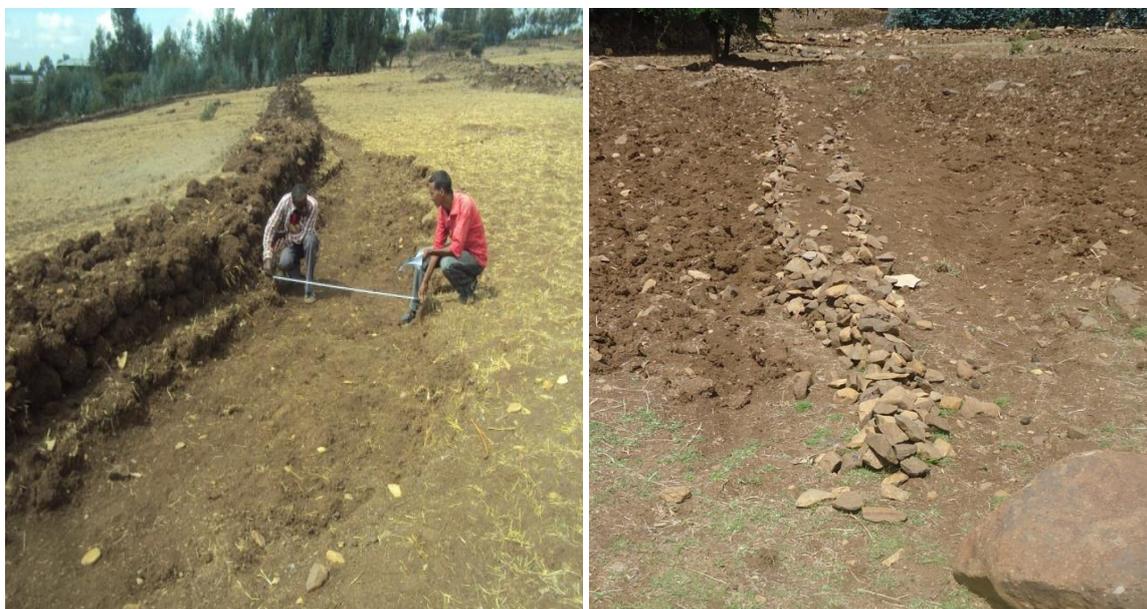
Figure 4: Improper bund channel design

Most of SWC structures implemented were not following proper survey based on standard to design the structures. Giving less attention to the orientation of the structures and slope of the land, improper placement of SWC treatments in spaces between the structures (Figure 4.) and wrong combination and application of design of structures (Figure 5) are the main design problems observed. Discussions with farmers showed that the main reason for the collapse of SWC structures was lack of knowledge and skill. This was not only for farmers but also for Development Agents. Most SWC structures were dismantled in the Shola watershed due to concentrated runoff overtopping the structures and improper tillage. This is in line with a study conducted by ^[8, 9] in the Koga watershed, Highlands of Ethiopia, where most farmers concluded that SWC technologies were poorly designed which was a major cause of gully erosion.^[10] Also found that the absence or incorrect construction of supporting structures increased the volume of surface runoff on cropland in such a way that structures cannot cope, and thus shortens their life and makes erosion reduction difficult. Another study in Southern Ethiopia ^[11] indicated that not following proper survey and standard design, little or no consideration of socio-economic profile of the area, less attention to the orientation and slope

of the land, improper placement of SWC treatments, wrong combination and application of design were found as the major implementation problems. Therefore, implementation of SWC measures based on the recommended packages can prolong the existence of the SWC structures. This results in increasing the sustainable land management by reducing soil loss from the farmland.
